Laser Removal of TSN color- top for Refurbishment

NRL Code 6138

Work Funded by Paint Center of Excellence, NAVSEA

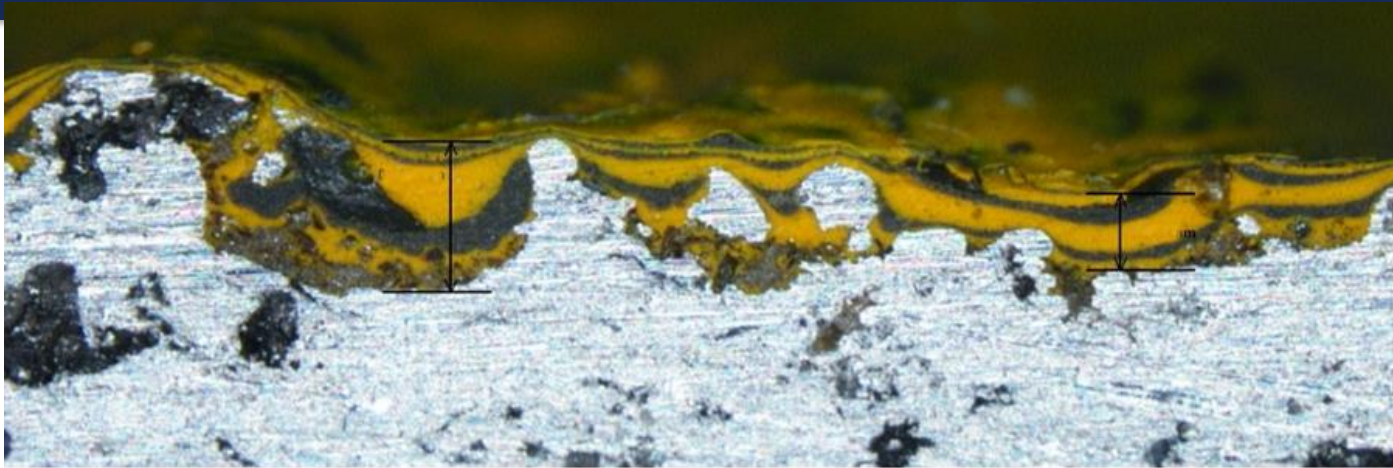
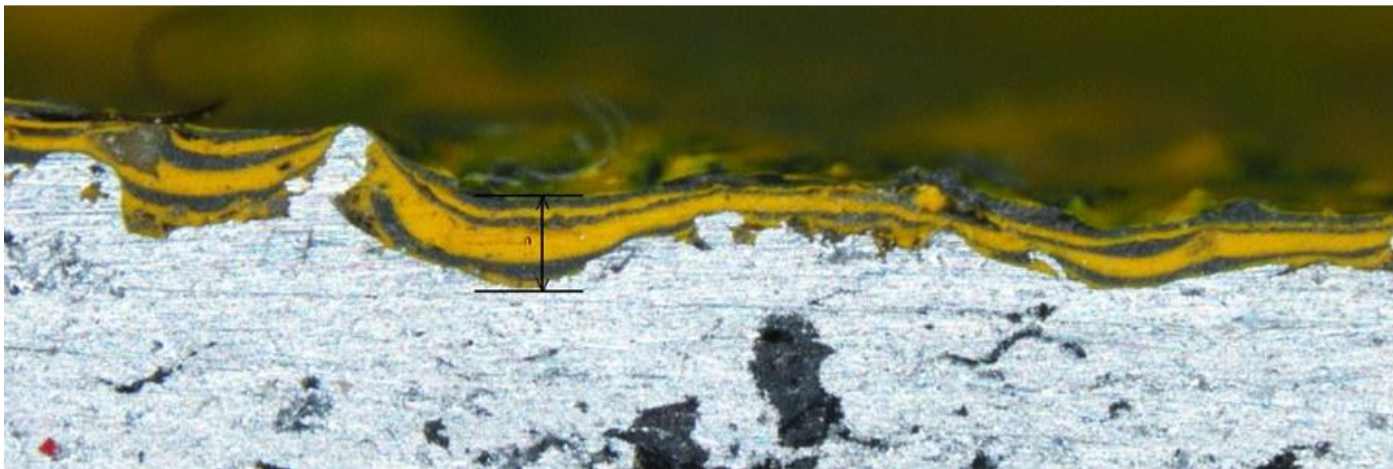
Impact of Multiple Recoats on TSN Profile

- 7 coats of the flat finish, single-component, siloxane color-top to be qualified to TT-P-28J
- Color-top is low viscosity and tends to settle in the valleys
- ***Begins to fill in TSN profile after 2-3 coats***

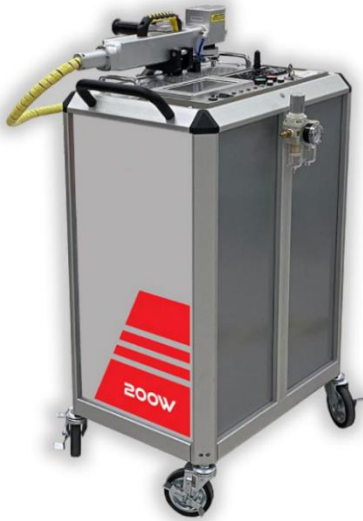
Removal Evaluation: 200W laser

- Testing was performed by the vendor using a 200W
- Removal efficiency was highly dependent on direction of cleaning
- Pulse marks were visible in the metalized TSN layer
- ***Recommend second round of testing to optimize settings and reduce visible pulse pattern***

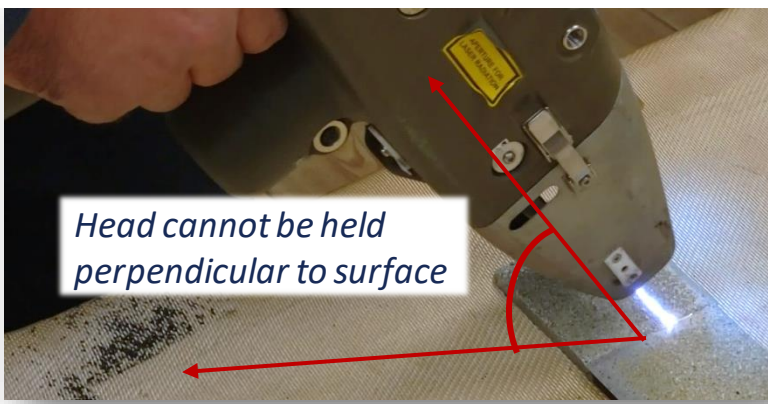
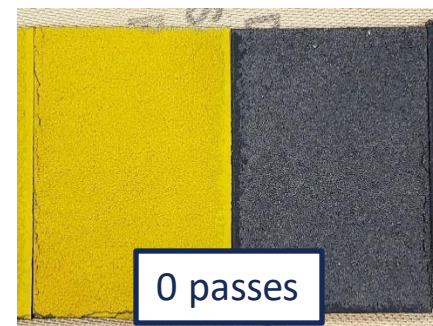
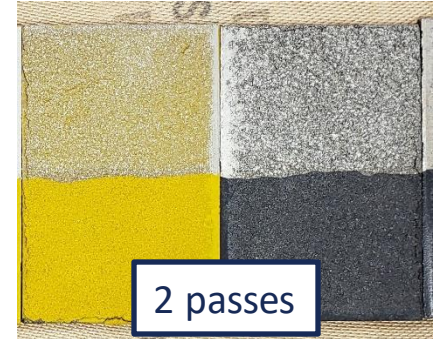
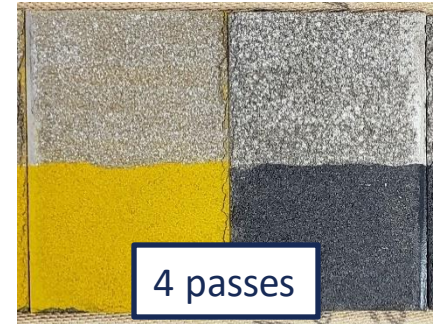
Removal Evaluation: 1000W laser

- Performed testing with manufacturer
- Beam intensity set to “high” (24 kHz) for all runs
- Cross-hatch pattern required for more thorough removal
- Removal efficiency highly dependent on angle of attack
- Produced no visible damage to the TSN

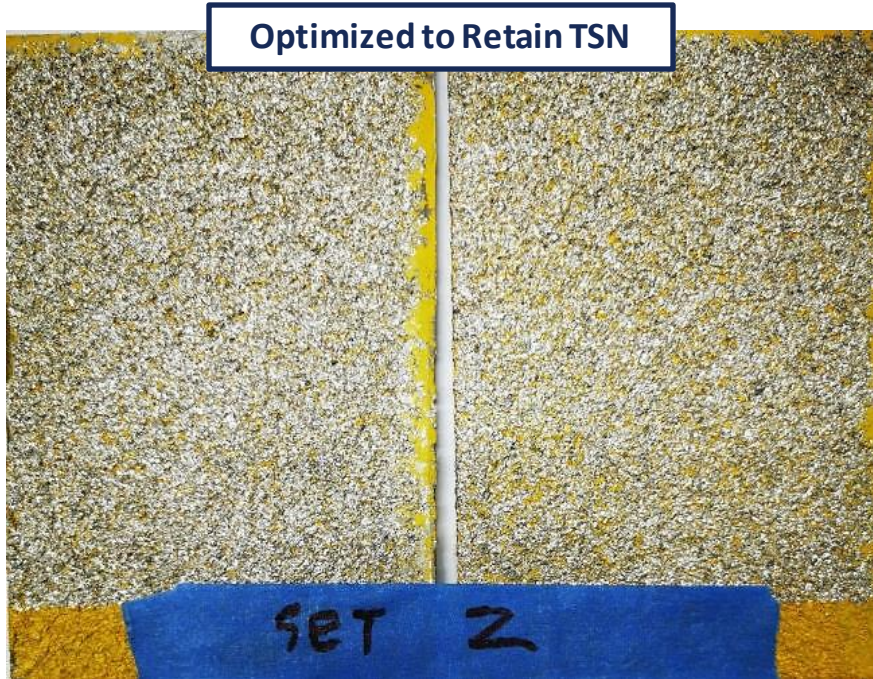
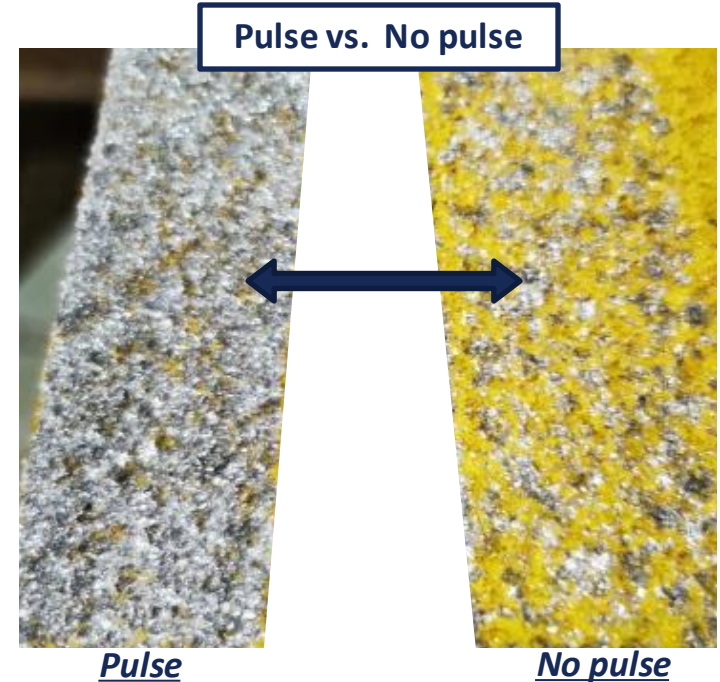
Removal Evaluation: forced-pulse waterjet (cont.)

- The goal was minimize the energy input required for removal so as to not damage the TSN
- Paint flecks left after removal provided a visual indication that removal energy was being minimized

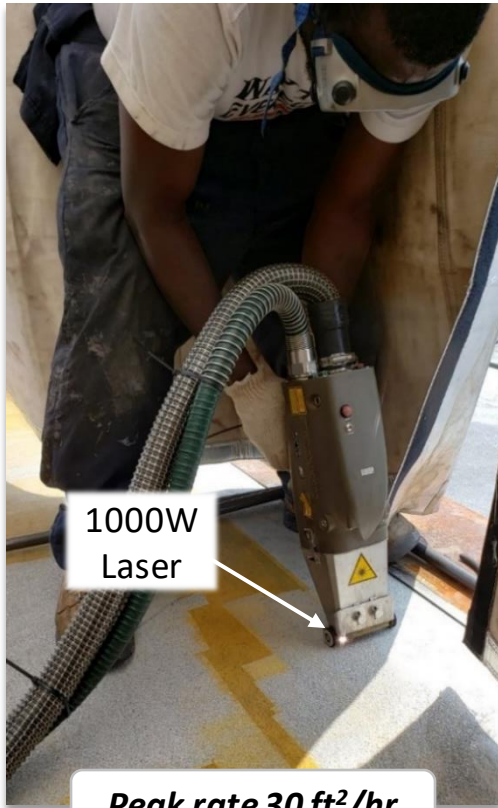
1000W
Laser

Peak rate 30 ft²/hr

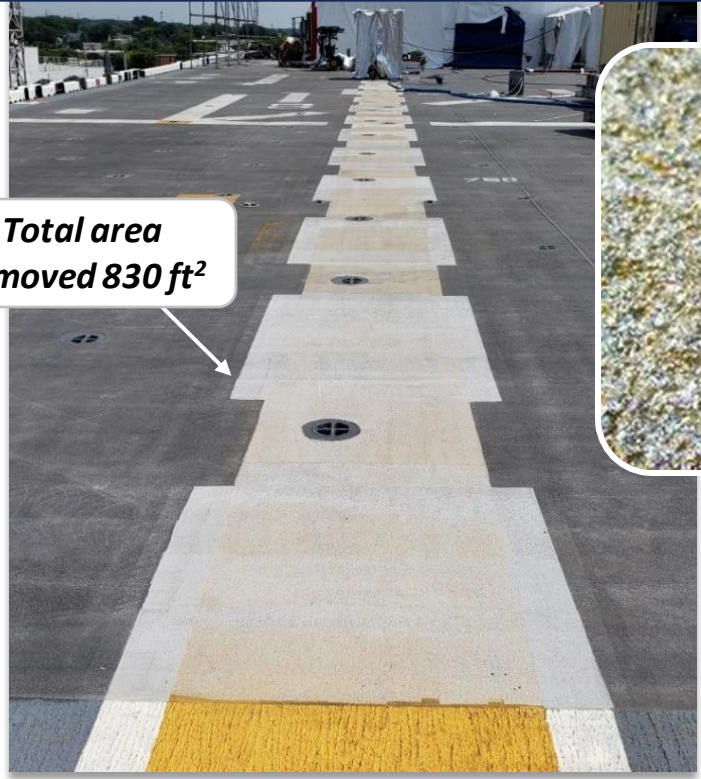
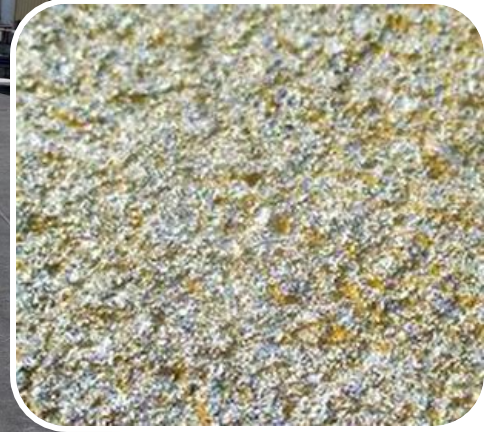
VLA after Color-top Removal

Total area removed 830 ft²

- Laser “on-time” average 6.1 hours of an 8 hour shift
- Removal rate averaged 15.1 ft²/hr with a peak removal rate of 30 ft²/hr
- Better trigger ergonomics or mounting the laser head to a crawler should boost production by at least 200%

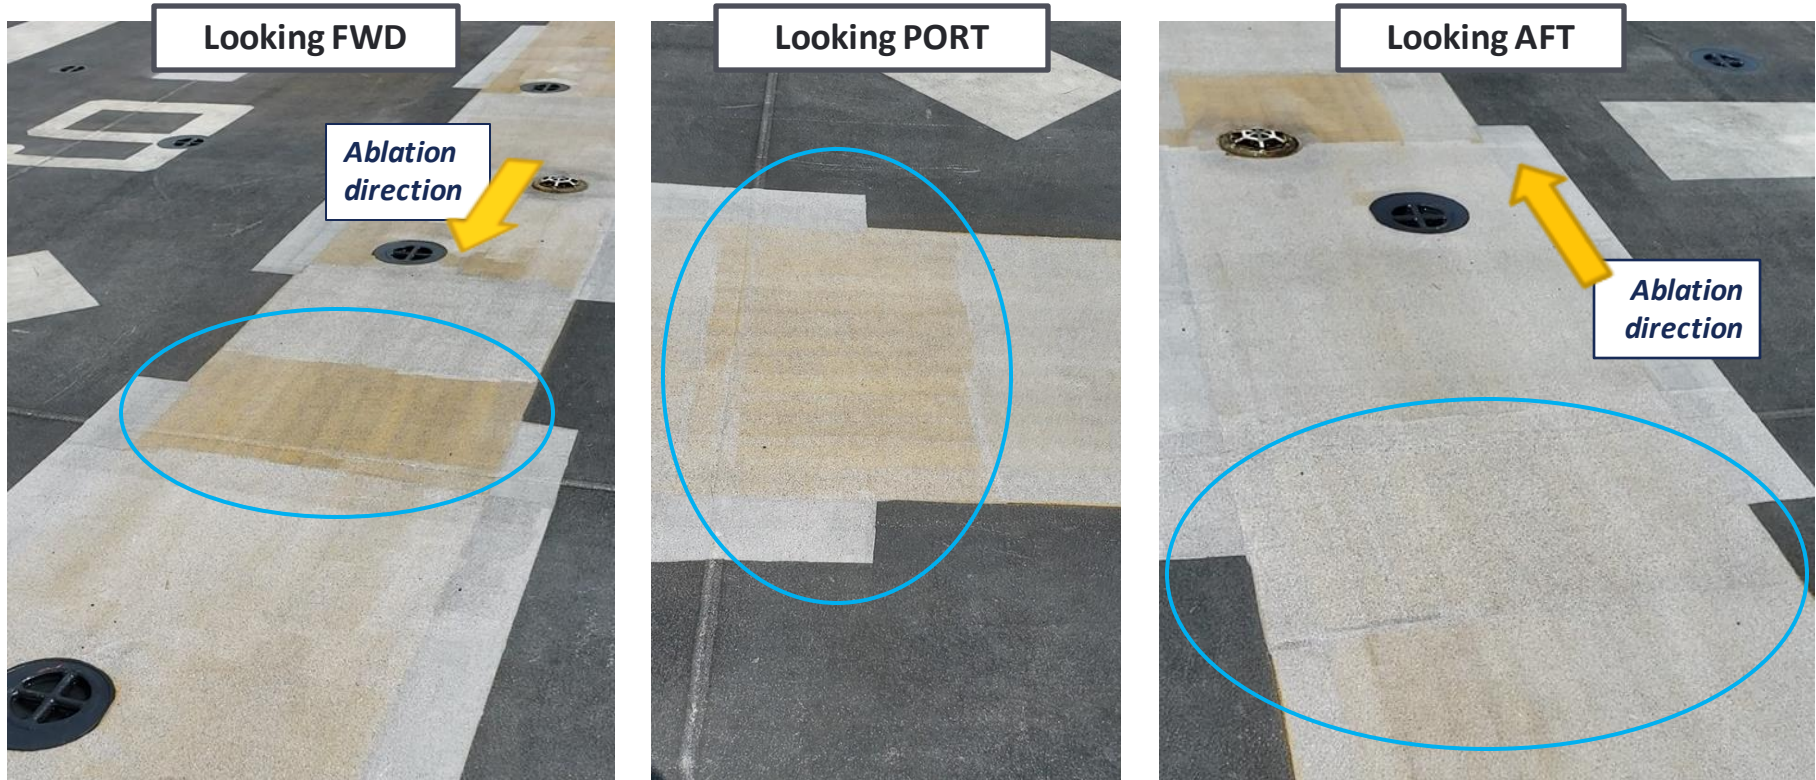
Ship Demo: shadowing effects

Same spot looking from 3 different vantage points

- The laser works by “line-of-sight”, so multiple approach angles are needed to reach recesses/crevices
- Multiple cleaning directions can improve efficiency
