Laser Removal of TSN color- top for Refurbishment

NRL Code 6138

Work Funded by Paint Center of Excellence, NAVSEA

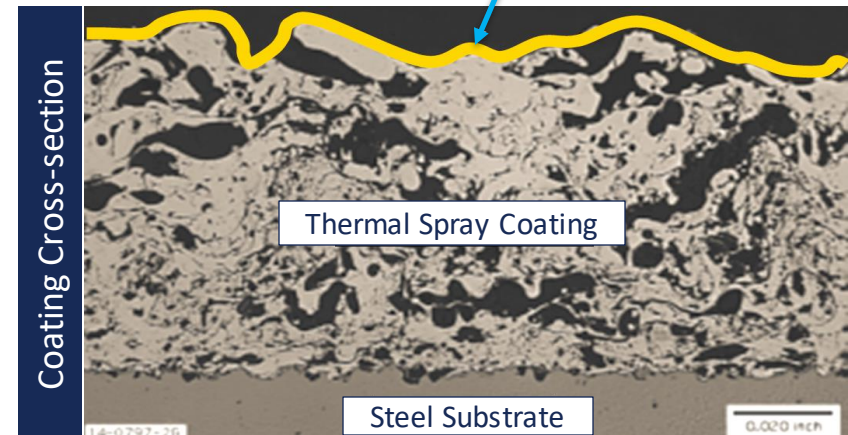
Color-top (polysiloxane)

- TSN inherently does not have the same ridges as traditional nonskid so color-top can build up and degrade the deck's coefficient of friction
- As a new deck coating system, there is no established process for removing color-top without damaging the underlying TSN

The goal is to remove the polymer color-top without damage to the underlying thermal spray

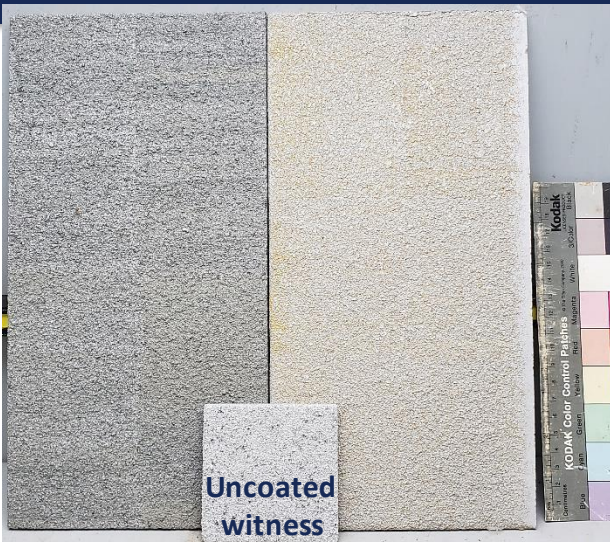
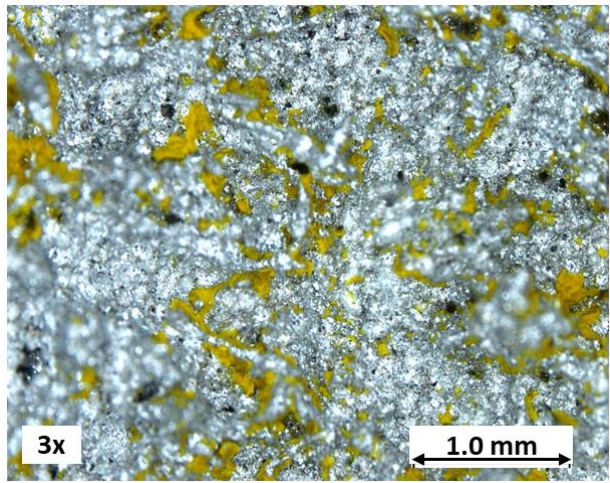
| Removal Method | Removal Efficiency | Removal Rate (ft ² /hr) | Static COF (before/after removal) | % TSN loss* | Notes |
|---|---|---|---|--|--|
| 200W Laser | 60-65% | 5-6 [yellow] 25 [gray] | 1.24 ± 0.12 [before] 1.25 ± 0.10 [after] | -1.3% (7 removal iterations) | Multiple cleaning directions needed to overcome shadowing effects of profile roughness |

- Testing was performed by the vendor using a 200W
- Removal efficiency was highly dependent on direction of cleaning
- Pulse marks were visible in the metalized TSN layer
- ***Recommend second round of testing to optimize settings and reduce visible pulse pattern***

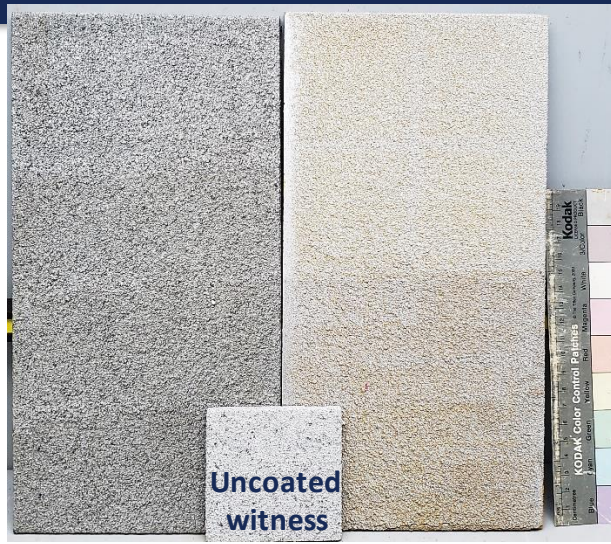
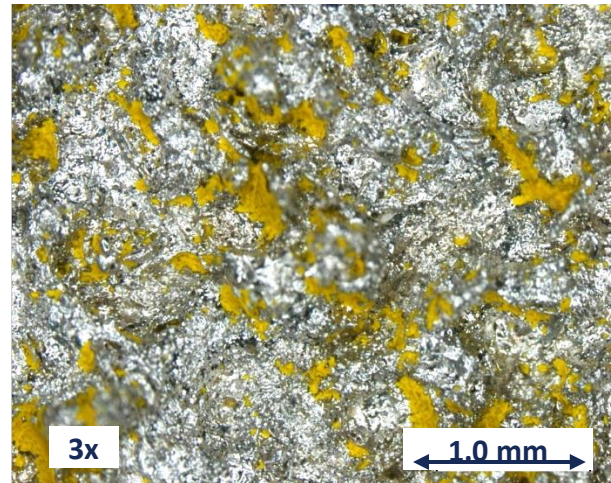
| Removal Method | Removal Efficiency | Removal Rate (ft ² /hr) | Static COF (before/after removal) | % TSN loss* | Notes |
|---|---|---|---|--|--|
| 1000W Laser | 55-60% | 31 [yellow] 60 [gray] | 1.24 ± 0.10 [before] 1.28 ± 0.13 [after] | 0% (7 removal iterations) | |

- Performed testing with manufacturer
- Beam intensity set to “high” (24 kHz) for all runs
- Cross-hatch pattern required for more thorough removal
- Removal efficiency highly dependent on angle of attack
- Produced no visible damage to the TSN

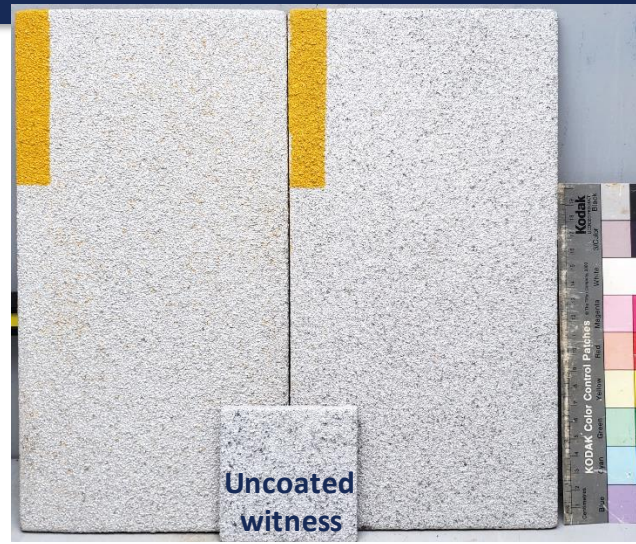
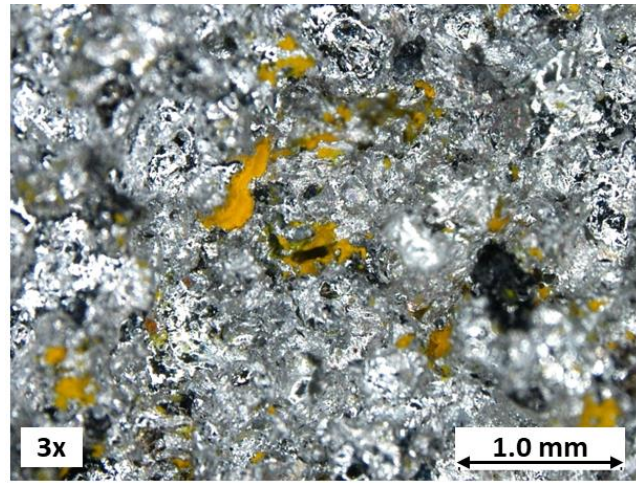
Forced-pulse waterjet

| Removal Method | Removal Efficiency | Removal Rate (ft ² /hr) | Static COF (before/after removal) | % TSN loss* | Notes |
|---|---|---|---|--|--|
| Pulse waterjet | 95% | 38 | 1.20 ± 0.12 [before] 1.24 ± 0.12 [after] | -2.2% (1 removal iterations) -6.4% (3 removal iterations) | Rate based on <u>single</u> nozzle; production |

- The goal was minimize the energy input required for removal so as to not damage the TSN
- Paint flecks left after removal provided a visual indication that removal energy was being minimized

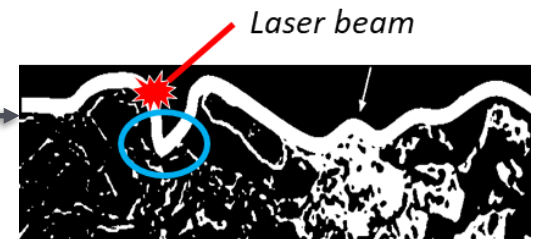
- The laser works by “line-of-sight”, so multiple approach angles are needed to reach recesses/crevices
- Multiple cleaning directions can improve efficiency
